ETHIOPIA

WASH in small and medium towns

AID 9428

PROJECT AID 9428 – THE EVALUATION REPORT

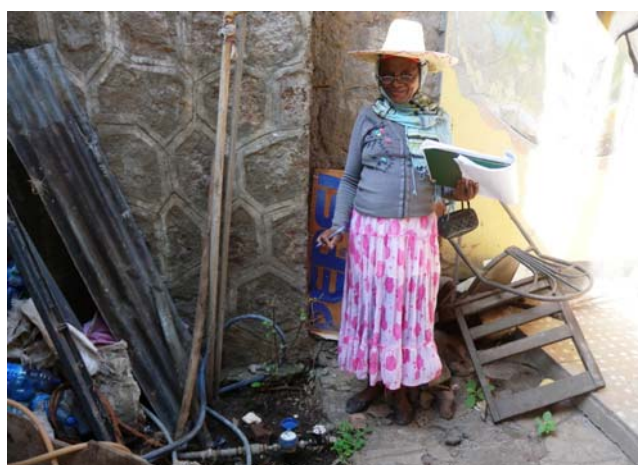
Fig. C.1.3: TWU billing reader at Huruta town

(*) The IT *Billing*, as confirmed by the local AICS was recently supplied but still not functioning.
